Fatal Accident Investigation Report.

Paul's Hair and Beauty World,
Oldham Street, Manchester.
July 13, 2013

GREATER MANCHESTER
FIRE AND RESCUE SERVICE

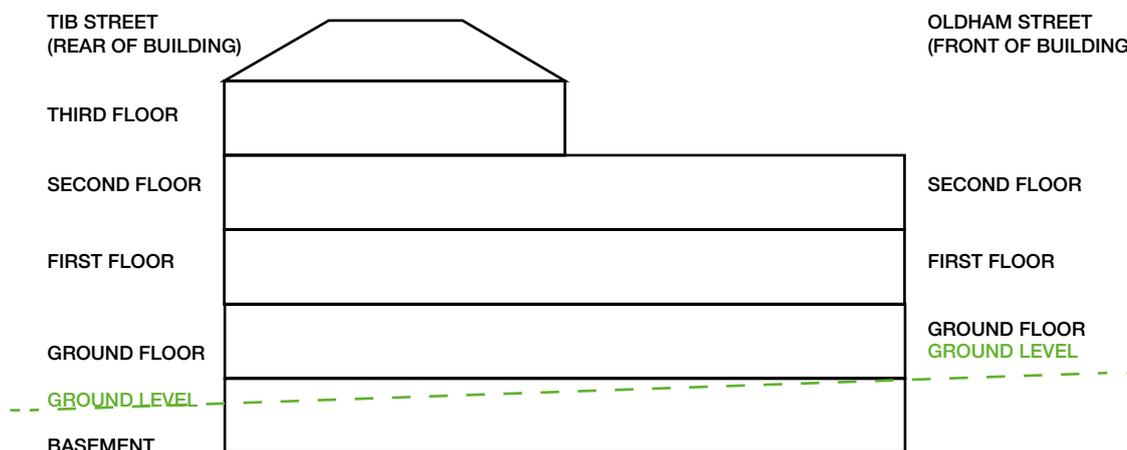
Figure 1: Side elevation of building

1.1.2 At the time of the fire on the July 13, 2013 Paul's Hair and Beauty World premises were located within a multi occupied building on Oldham Street Manchester. The building, known as Plaintree House consists of four floors and a basement. Due to being built on sloping ground the front elevation has three storeys whilst the rear of the building is four. At the rear, ground floor level of the building is six steps above the ground level with the basement only partly below ground. Figure 1 below illustrates a side elevation of the building, showing this change in floor level.

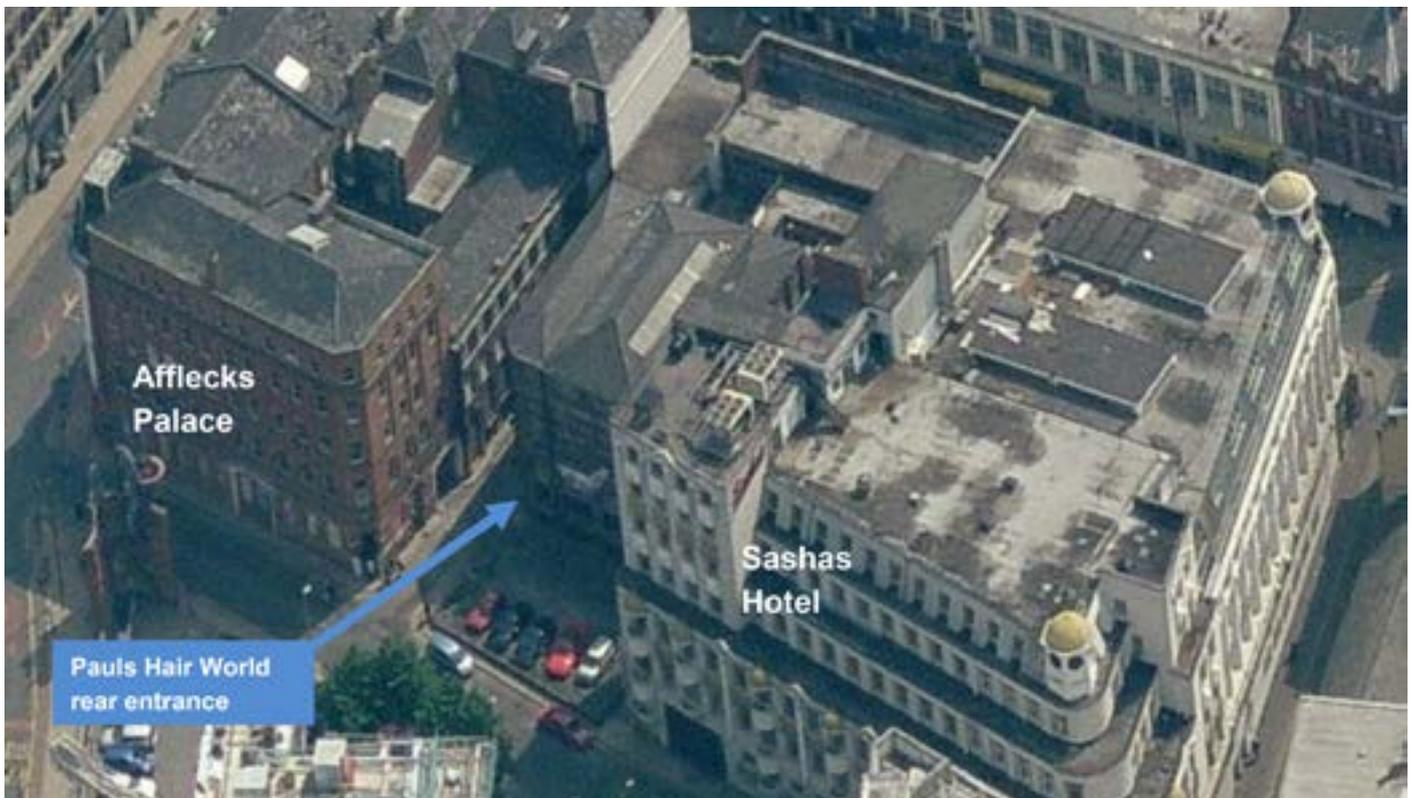
(Photograph 1)

Aerial view showing rear of Paul's Hair World

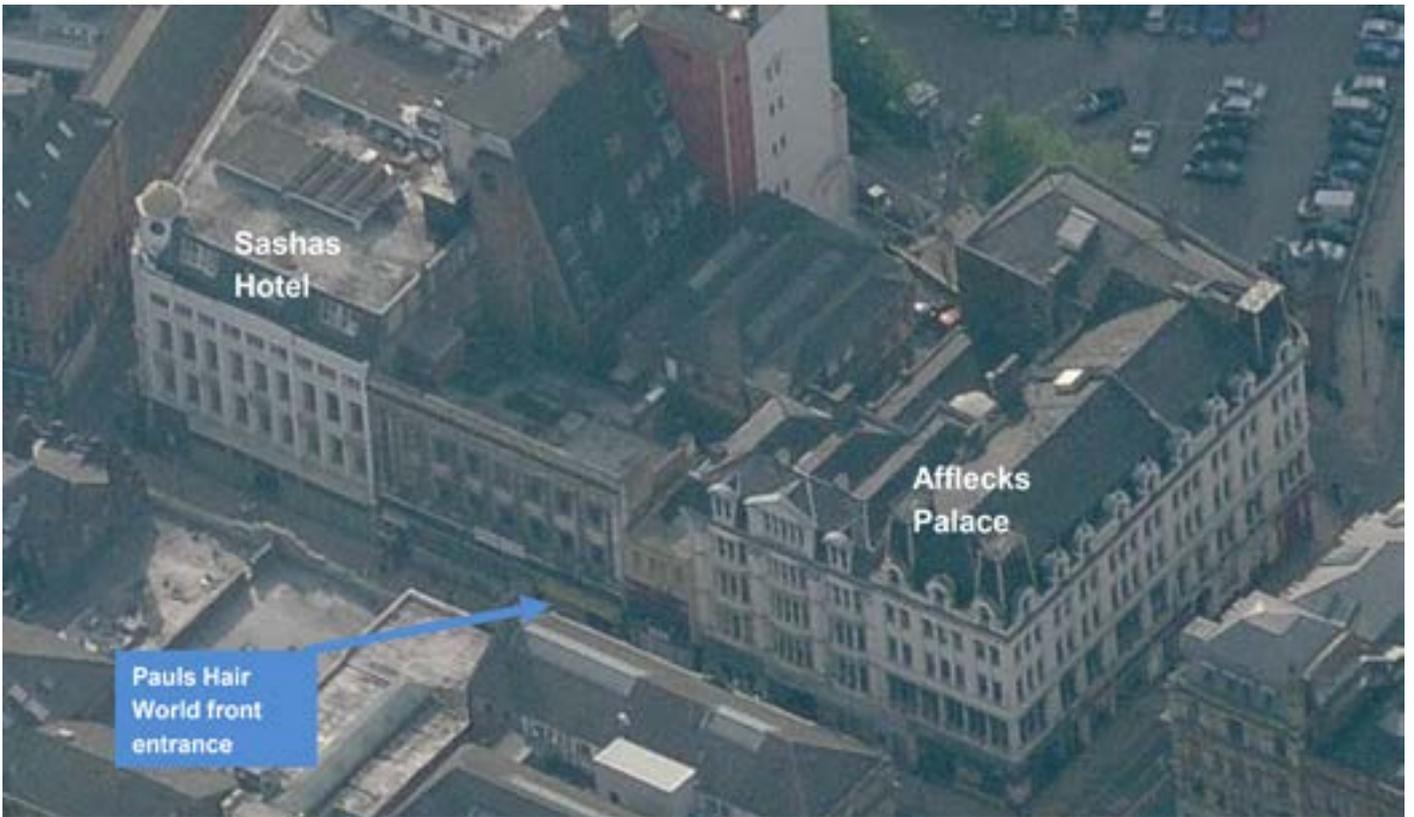
(Photograph 2)

Aerial view showing front of Paul's Hair World

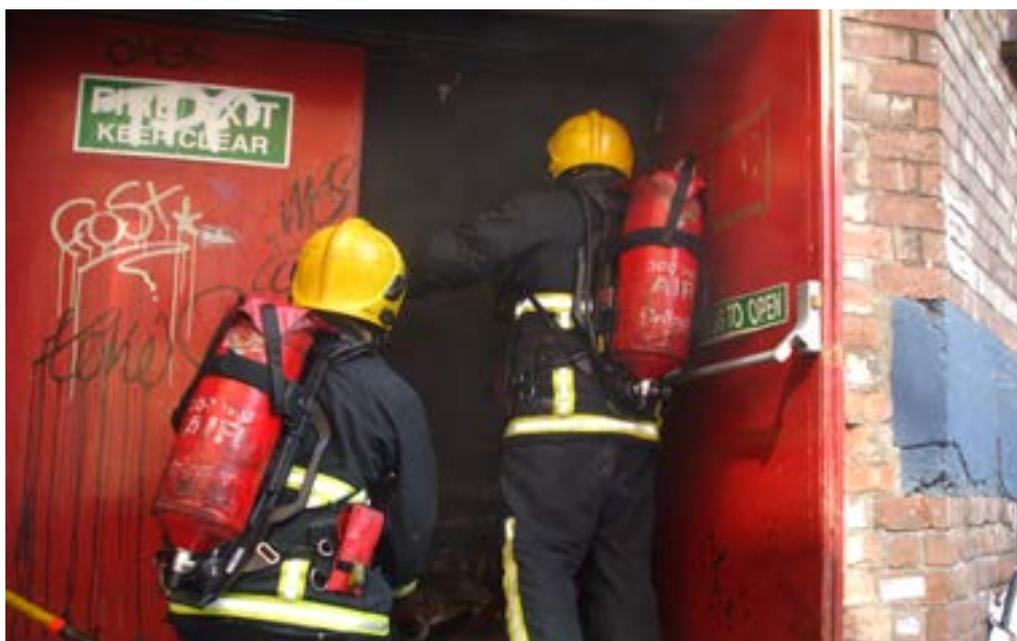
(Photograph 3)

- 1.3.3** Shortly after their arrival and following a dynamic risk assessment (DRA) the Watch Manager at the rear of the premises committed a breathing apparatus (BA) team in through doorway 'A'. They were briefed to make the initial attack on the fire from just inside the doorway and to gather information as to the extent of the fire and conditions inside.

Firefighters entering doorway 'A'

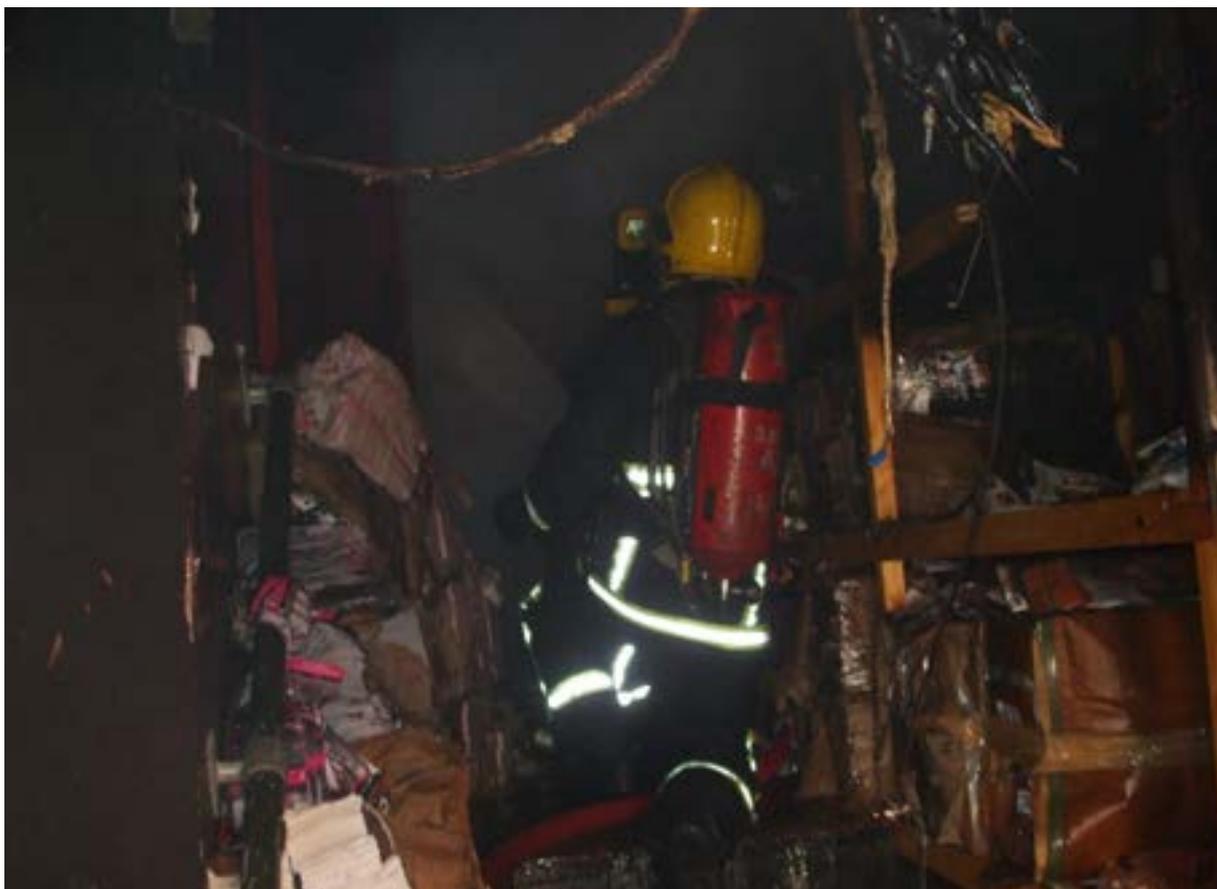
(Photograph 5)

Firefighter on staircase 'A' inside doorway 'A'

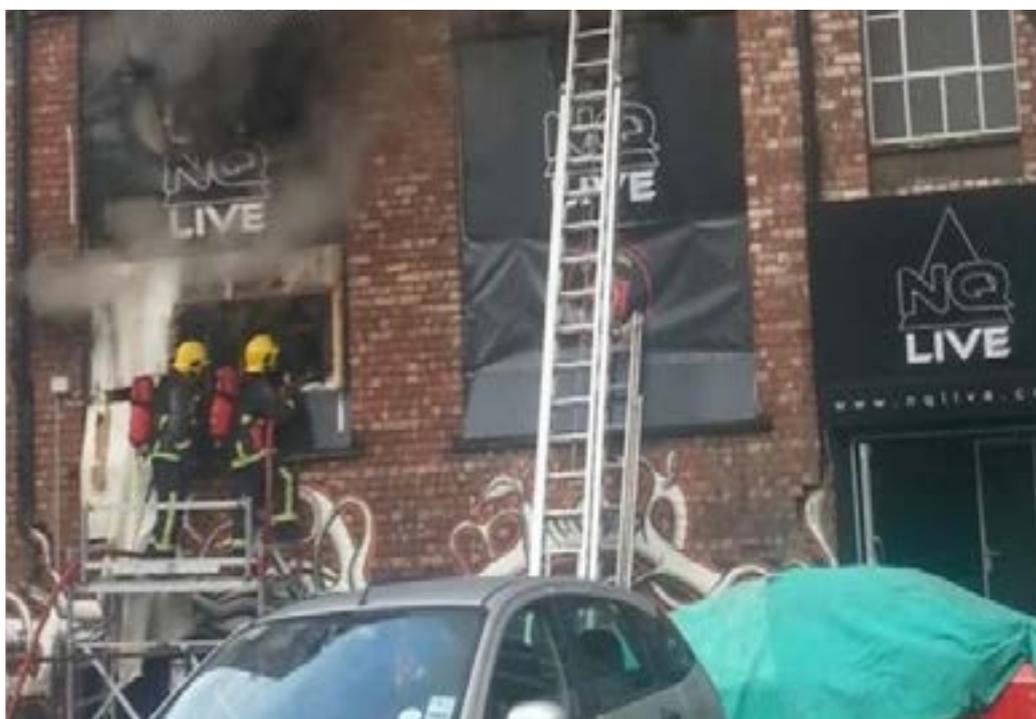
(Photograph 6)

- 1.3.46** Shortly before 17:30 an opening was created at the rear of the building in between doorway 'A' and staircase 'C'. An external hoarding was removed and the block work from a former window was breached. This meant that a further jet could be played into the stock area. In order to aid this water application, and due to the elevated aspect of the opening, a temporary working platform from the Enhanced Rescue Unit (ERU) was erected and placed under the opening. BA wearers committed through Sector One Entry Control Point (ECP) worked off this platform throughout the course of the incident.

Firefighters directing jet from working platform

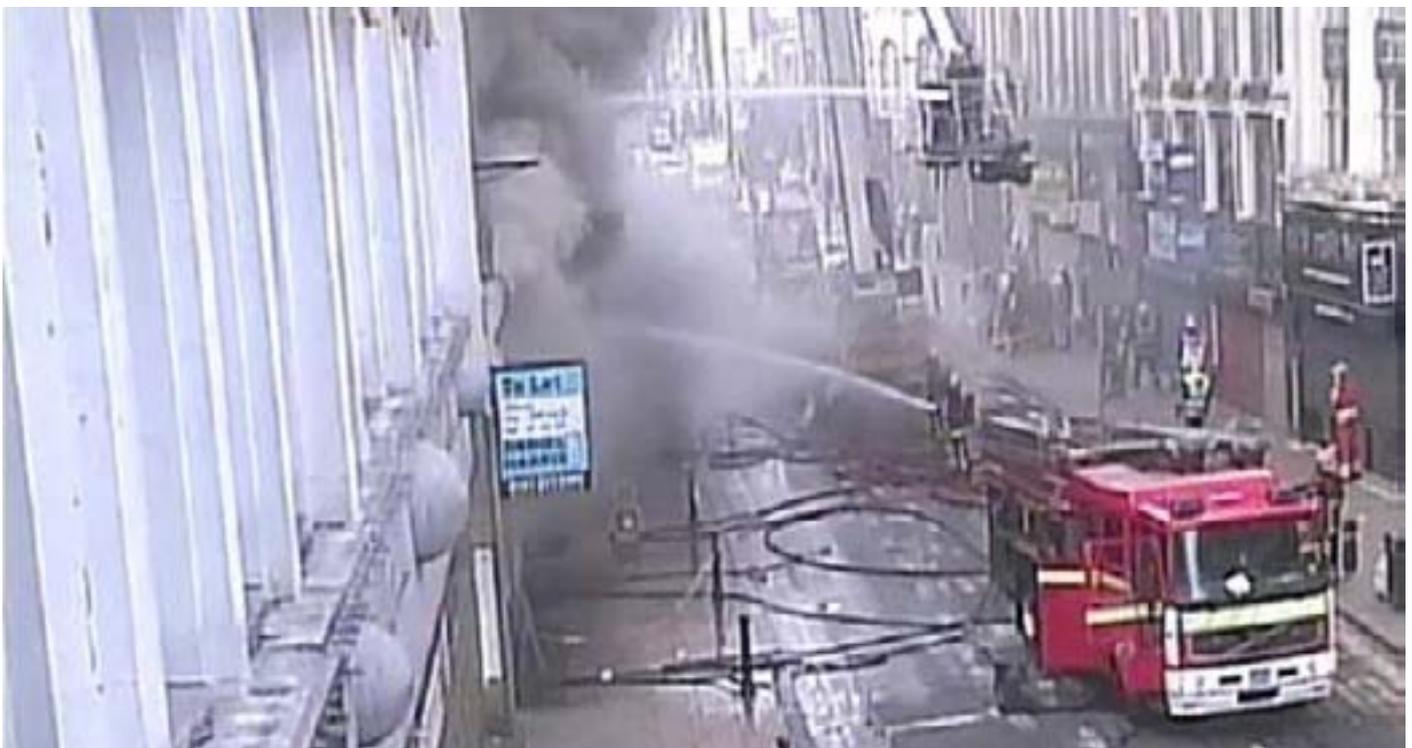
(Photograph 7)

- 1.4.3** With the BA crews again withdrawn due to the worsening conditions and the fire spreading, to protect the hotel, the Operations Commander decided to deploy the aerial appliance monitor through the first floor windows in Sector Three. This information was recorded by way of the following informative message at 19:18; *'All BA withdrawn from inside the building due to worsening conditions. Fire has broken through to the first floor. Aerial appliance and jets being directed through the first floor windows'*.

Aerial appliance delivering water into first floor

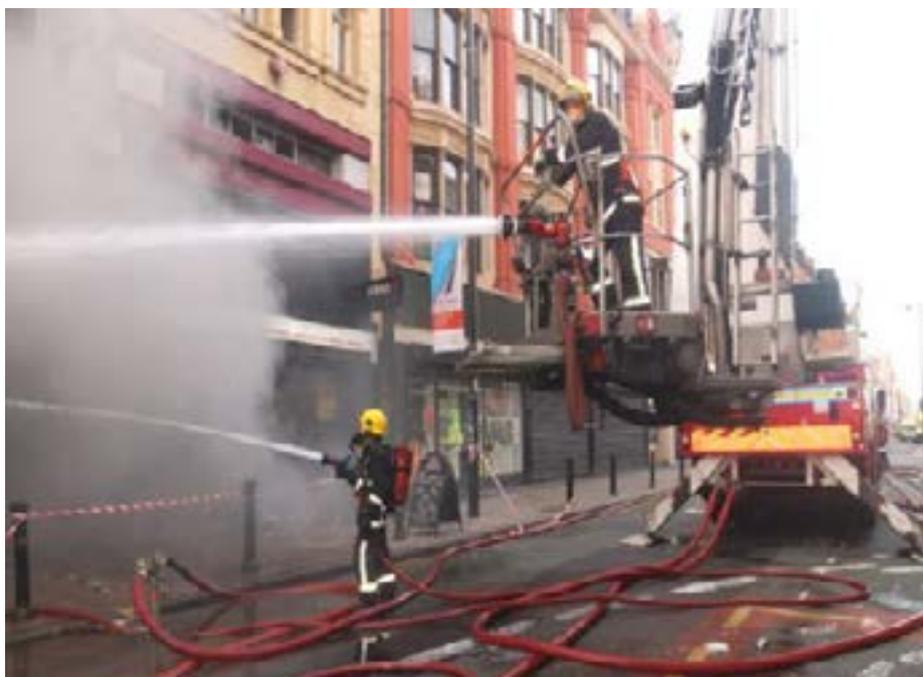
(Photograph 8)

1.7.32 In Sector Three (at the front of the building on Oldham Street), shortly before 20:17, the Night Shift Sector Three Sector Commander that the aerial appliance, which was training its monitor through the first floor windows, was not having much effect. He stated that he could see visible flames in the smoke at ground floor level and could hear explosions. To address this he decided to move the aerial monitor from directing water into the first floor to directing water into the ground floor. Prior to this action there was no communication with any of the Command Team or any other area of the fire ground.

Aerial appliance delivering water into ground floor

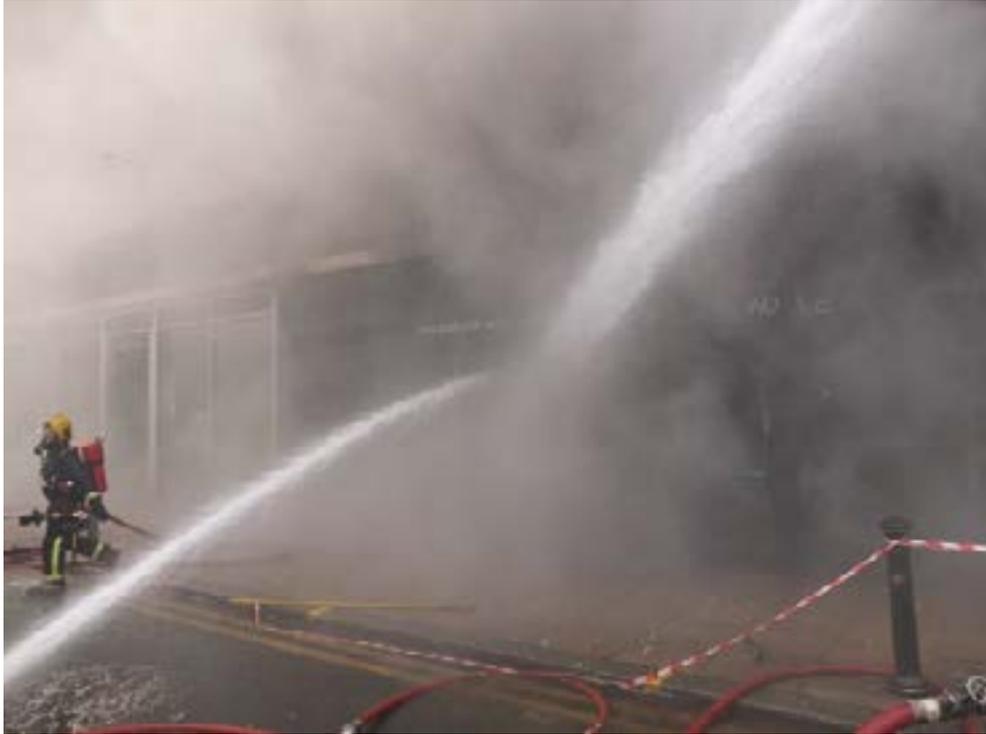
(Photograph 9)

Aerial monitor and a jet into the ground floor
