**GREATER
MANCHESTER**
FIRE AND RESCUE SERVICE

The Cube

Incident Report and Key Observations
regarding the fire which occurred on

15 November 2019

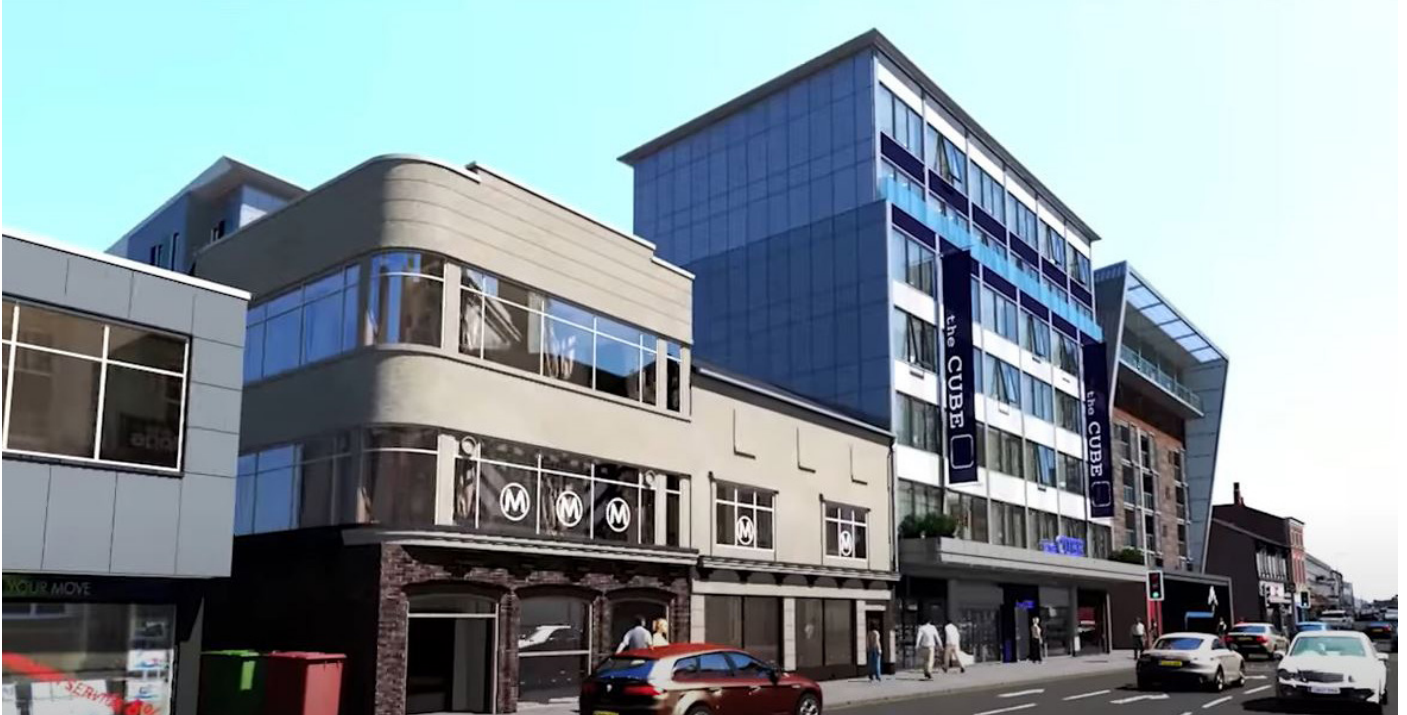
Illustration 1: The Cube – Bradshawgate aspect (courtesy of KRI Property Group)

- 64.** The Cube building is a privately owned and operated multi-occupied residential building consisting of 221 units (bedroom and bathroom) with shared communal kitchen and social areas. It opened in 2015 and offered luxury studio and en-suite cluster flats, primarily marketed to students at the University of Bolton.

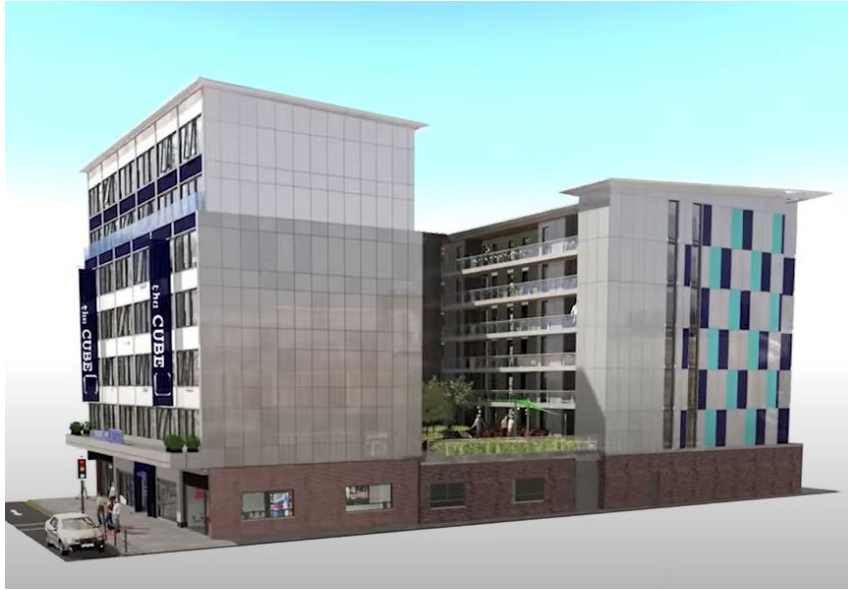
Illustration 2: The Cube – Southern aspect (courtesy of KRI Property Group)

- 65.** The Cube is separated into two parts; Phase 1, overlooking Bradshawgate, was an existing office building refitted and refurbished as student accommodation with the addition of two floors onto the existing structure. Phase 2 is purpose built, and stands behind Phase 1, separated by a decked terrace / open courtyard area accessible from the internal common area, above a small car park.

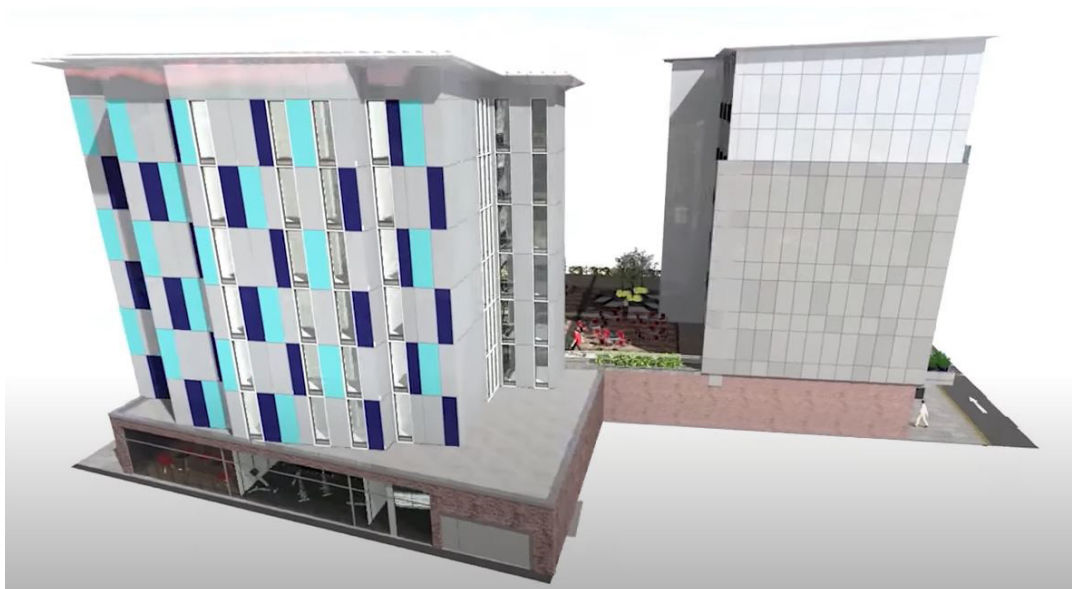
Illustration 5: The Cube – Northern aspect (courtesy of KRI Property Group)

- 66.** Phase 2 is a seven storey block, rectangular in shape, the inside aspect provides the deck access which overlooks the podium between the two phases, the decks at each level are the access routes to the individual flats. Both Phases are clad with HPL. Phase 1 is classified as a high rise building and Phase 2 is recorded as being under 18 metres and therefore not classified as a high rise building. As The Cube is student accommodation it is fitted with a fire alarm system and operates a simultaneous evacuation strategy.
- 67.** The Cube was not fitted with a fire suppression system, e.g. sprinklers.

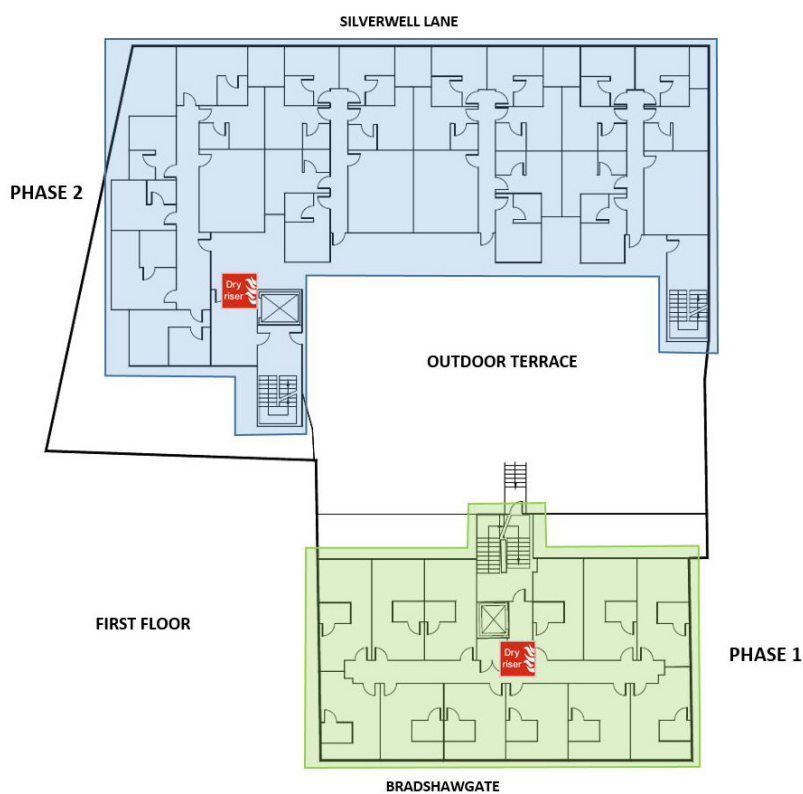
Drawing 2: The Cube – First Floor, detailing Phases 1 and 2, outdoor terrace and riser outlets

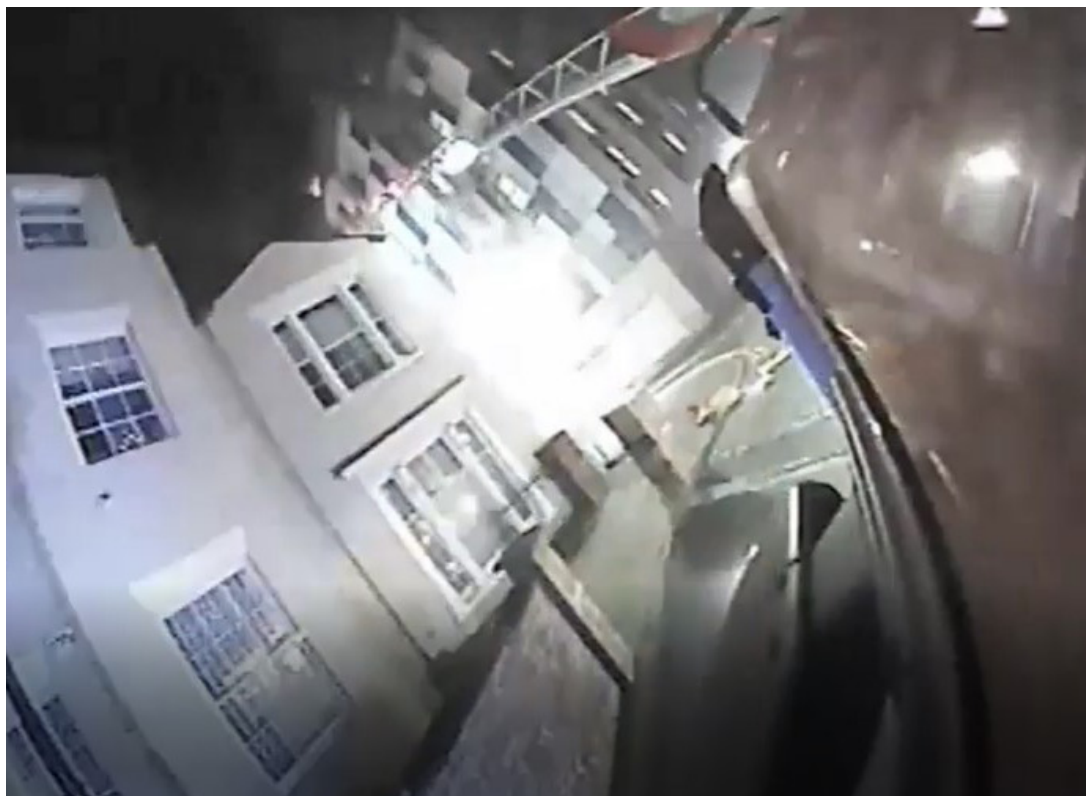
Image 5: Appliance CCTV (TTL) showing 32 metre ladder extended to sixth floor of The Cube to effect a rescue

- 102.** Within the first 30 minutes two rescues were performed. One female resident was rescued from a sixth floor window with the aid of the 32 metre TTL. It should be noted that almost immediately following the rescue of this resident by the high reach appliance, the flat she was rescued from became engulfed in smoke and fire, and was subsequently destroyed.
- 103.** Shortly following this rescue a further resident was located as trapped on the second floor. Firefighters pitched a short extension ladder to access a first floor flat roof section. A further section of ladder was pitched from the first floor flat roof within a recessed atrium to access the second floor window. The resident was rescued from the window and led down to safety via the pitched ladders.

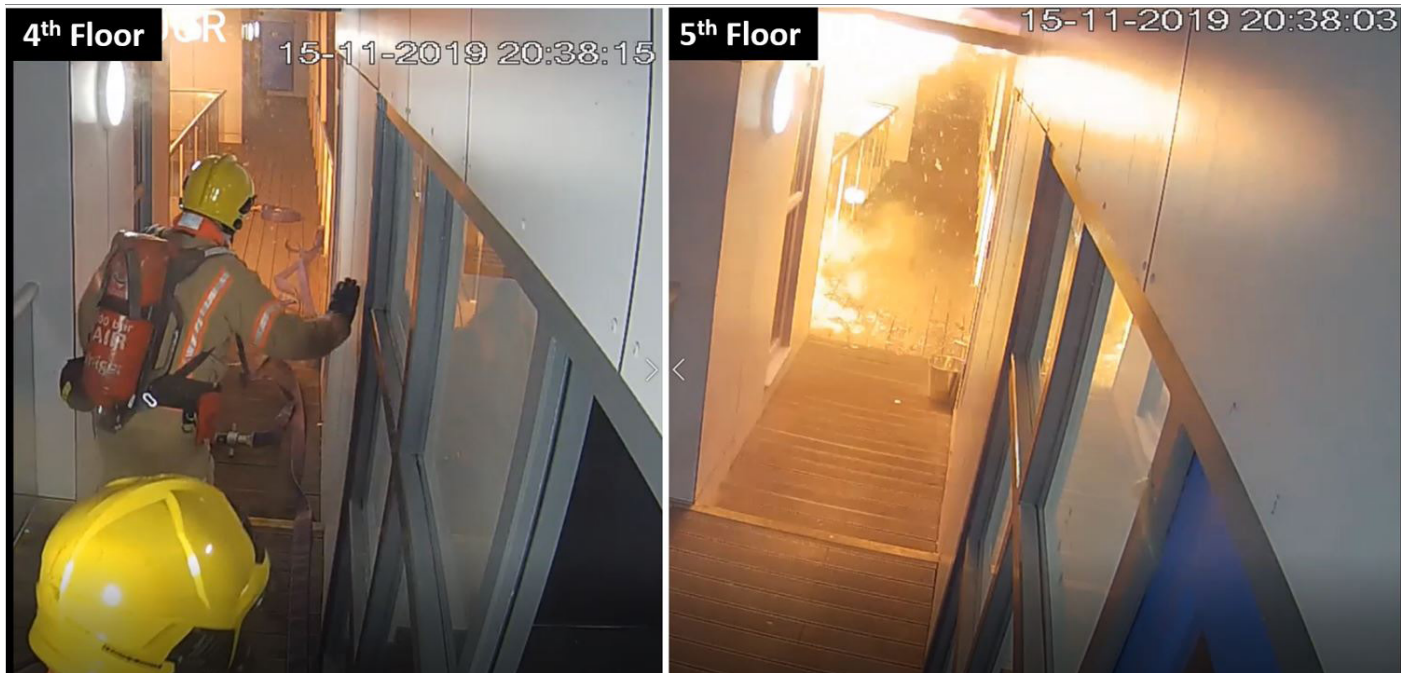
Image 8: Internal CCTV 20:38hrs – 15th November 2019

- 95.** The simultaneous images below were captured on The Cube's CCTV, showing fire development on the fifth and fourth floors at 20:38 hours, 10 minutes after the first 999 call.

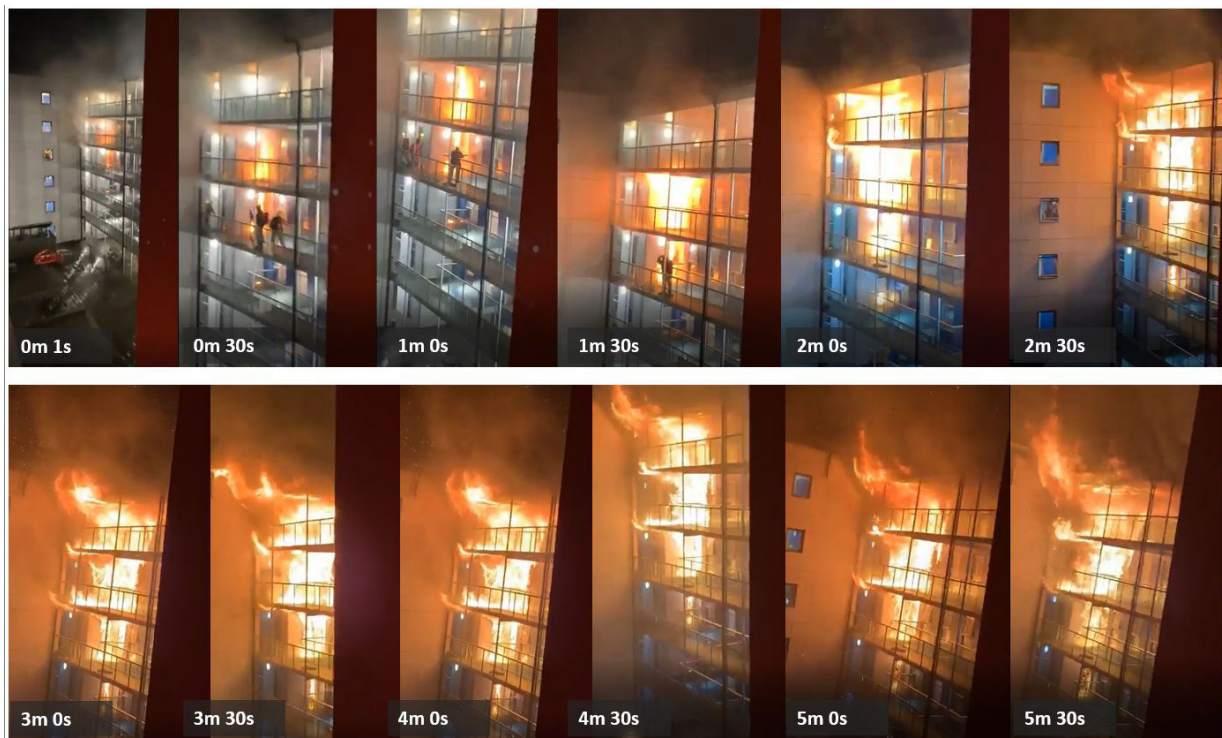
148. Firefighters attending the scene were faced with rapidly developing and unpredictable fire spread. Burning debris falling from the sixth floor, collected within the recessed façade of the building at ground level, developing further seats of fire. This was particularly noticeable in the atrium area between the north stairwell and the accommodation. The fire then spread upwards, causing large amounts of radiant heat from roof level.

Image 8: The Cube - collation of still images taken from video footage recorded within 10 minutes of initial 999 call - 15th November, 2019

149. Fire spread through the accommodation block and lift lobby, with subsequent failure of glass partition walls. Significant fire damage was observed throughout the decking outside the flat entrance doors.

- 150.** The fire spread laterally across the upper aspect of the building to involve the entirety of the roof. Further seats of fire developed at the rear of the building as burning debris fell into recesses at floor level. Again, fire spread the height of the building with smoke, heat and fire entering flats on each level as windows failed.
- 151.** With the additional resources in attendance, the building was surrounded with firefighting jets of water from ground level from within the open courtyard / terrace area and from the Silverwell Lane aspect, from neighbouring buildings, and from high reach AAs.

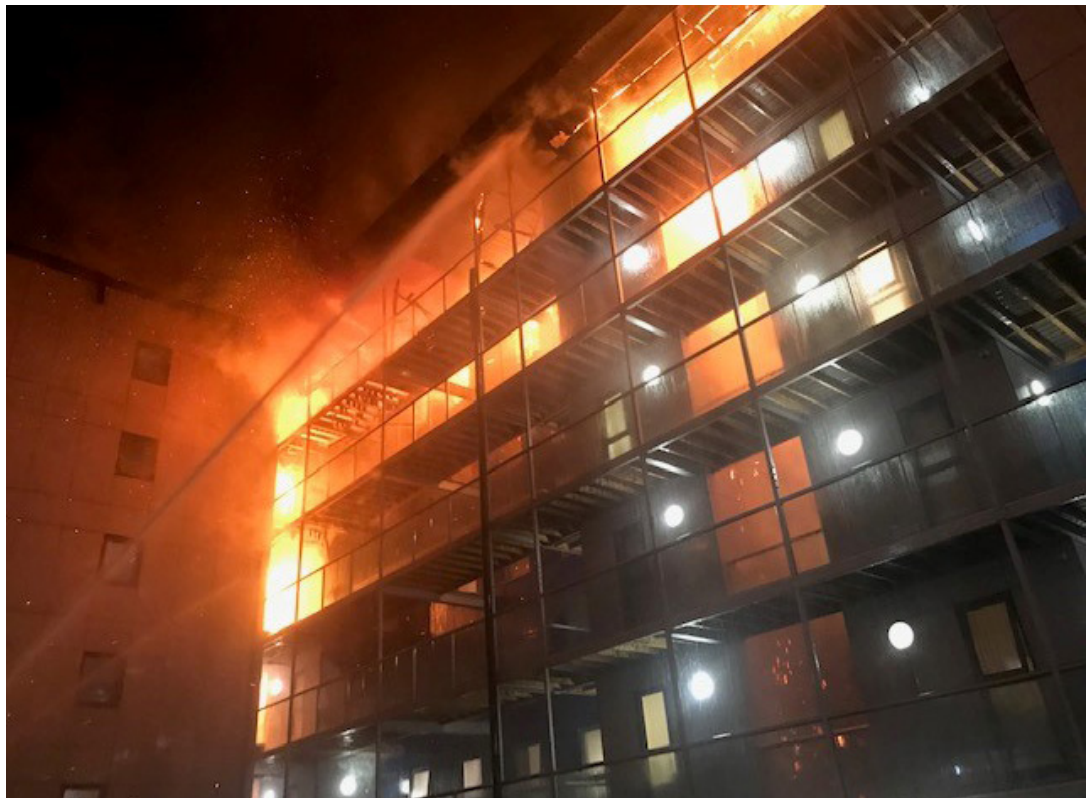
Image 9: The Cube – Phase 2 – 15th November 2019

- 152.** Below level six, the internal compartmentation appeared to be largely effective in checking the spread of fire. Level six, however, was fully engulfed in flames and completely destroyed.
