The Cube

Incident Report and Key Observations regarding the fire which occurred on

15 November 2019

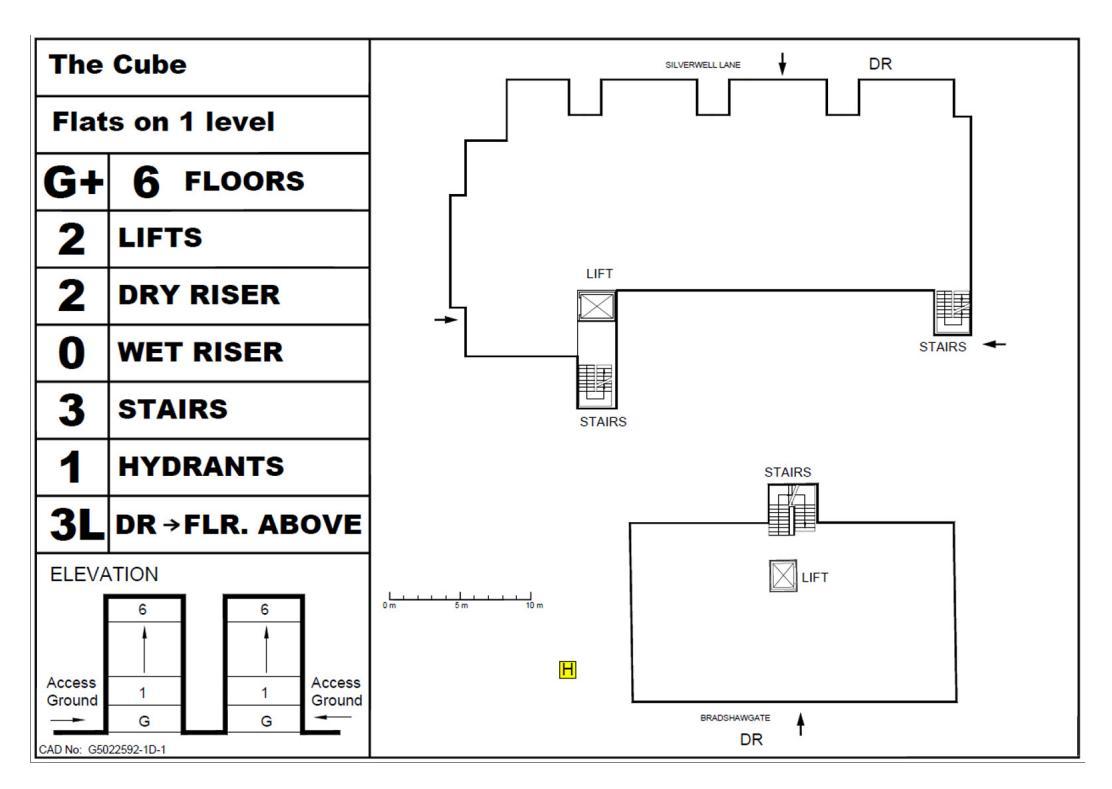
Diagram 1: The Cube – High Rise Plaque

- 77. One standard element of the OIS records for high rise buildings in Greater Manchester is the development of a 'High Rise Plaque' which forms part of the record and is available via the MDT of each fire engine.

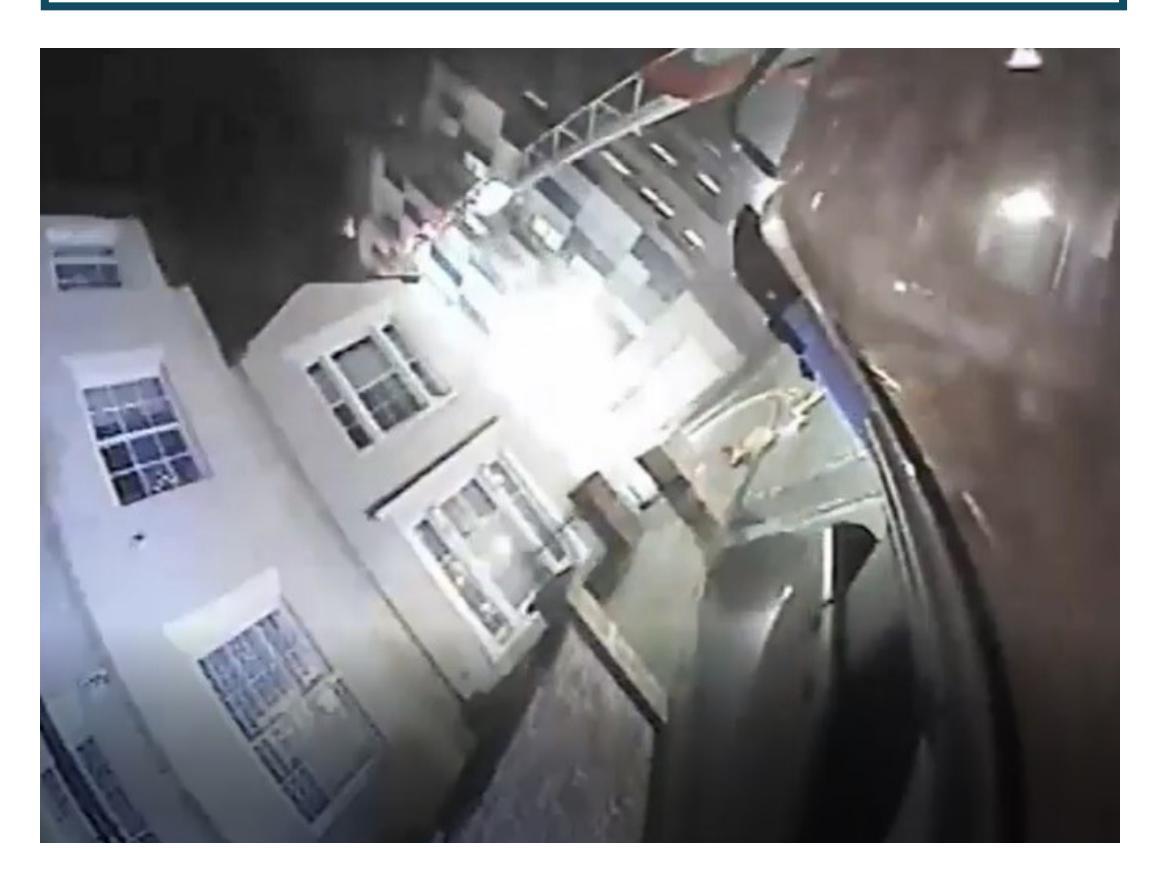
Image 5: Appliance CCTV (TTL) showing 32 metre ladder extended to sixth floor of The Cube to effect a rescue
Following the rescue from the sixth floor another occupier was reported and located by crews by a window at the rear of the building on the second floor. The resident was subsequently rescued by crews using a short extension ladder.

- **102.** Within the first 30 minutes two rescues were performed. One female resident was rescued from a sixth floor window with the aid of the 32 metre TTL. It should be noted that almost immediately following the rescue of this resident by the high reach appliance, the flat she was rescued from became engulfed in smoke and fire, and was subsequently destroyed.
- **103.** Shortly following this rescue a further resident was located as trapped on the second floor. Firefighters pitched a short extension ladder to access a first floor flat roof section. A further section of ladder was pitched from the first floor flat roof within a recessed atrium to access the second floor window. The resident was rescued from the window and led down to safety via the pitched ladders.

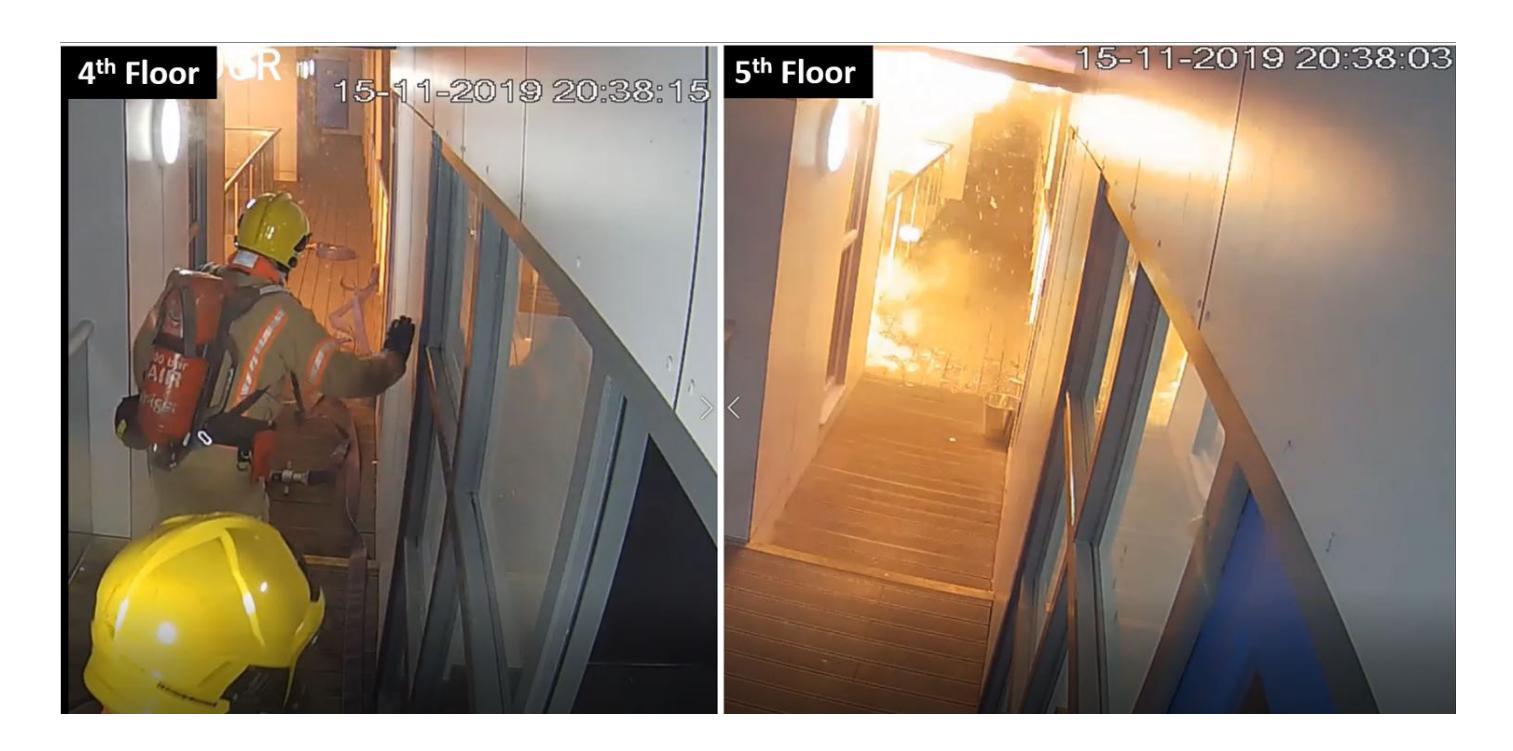
Image 8: Internal CCTV 20:38hrs – 15th November 2019

- 95. The simultaneous images below were captured on The Cube's CCTV, showing fire development on the fifth and fourth floors at 20:38 hours, 10 minutes after the first 999 call.

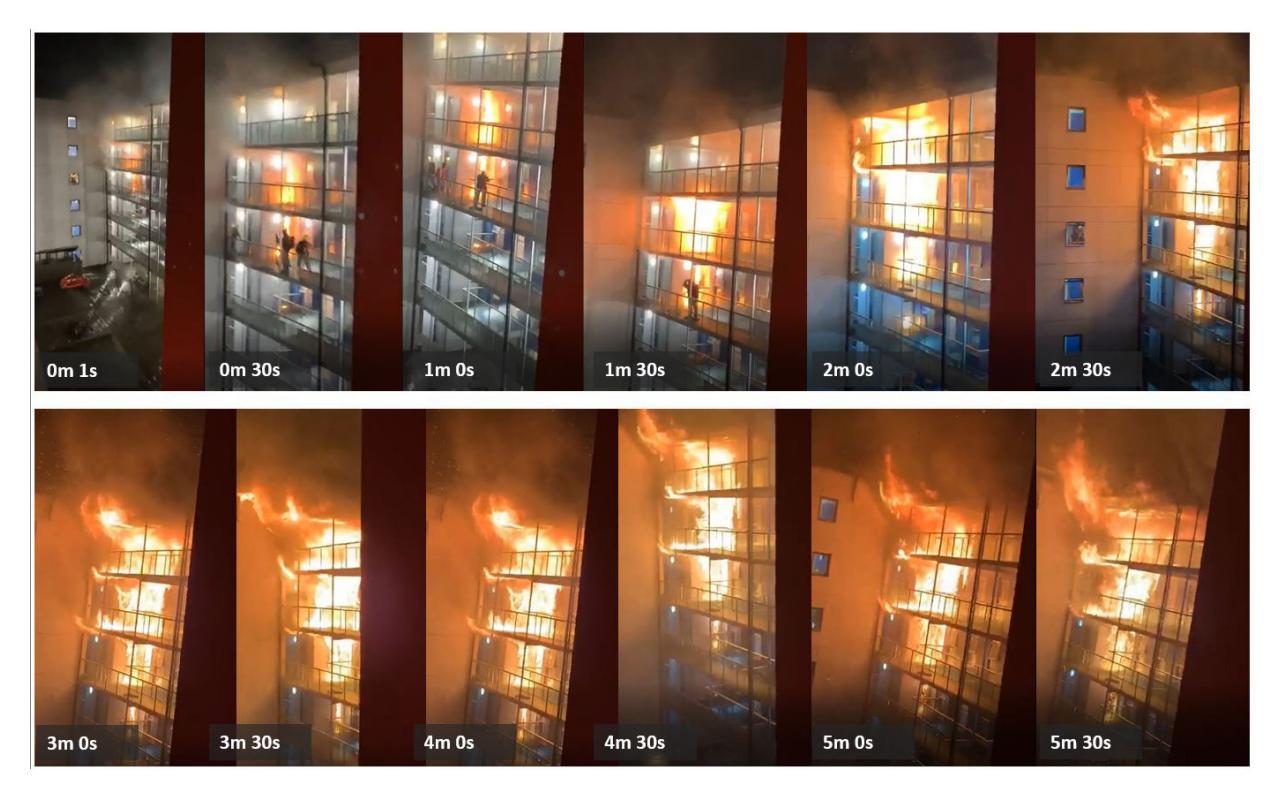
148. Firefighters attending the scene were faced with rapidly developing and unpredictable fire spread. Burning debris falling from the sixth floor, collected within the recessed façade of the building at ground level, developing further seats of fire. This was particularly noticeable in the atrium area between the north stairwell and the accommodation. The fire then spread upwards, causing large amounts of radiant heat from roof level.

Image 8: The Cube - collation of still images taken from video footage recorded within 10 minutes of initial 999 call - 15th November, 2019

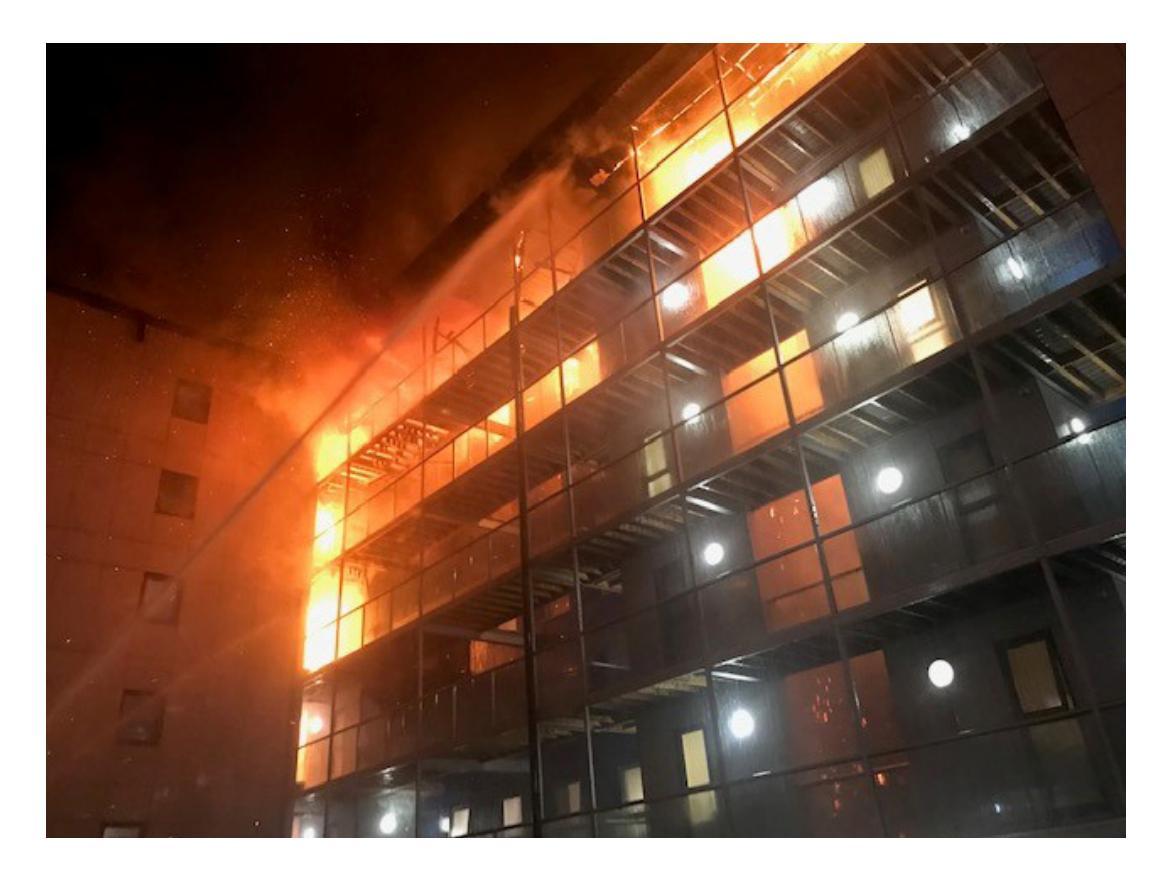
Image 9: The Cube – Phase 2 – 15th November 2019

- **152.** Below level six, the internal compartmentation appeared to be largely effective in checking the spread of fire. Level six, however, was fully engulfed in flames and completely destroyed.
